# **REAL-TIME MONITORING OF A MULTIPLE RETROGRESSIVE LANDSLIDE**

**A Thesis Submitted to the  
College of Graduate Studies and Research  
in Partial Fulfillment of the Requirements for the  
Degree of Master of Science  
in the Department of Civil and Geological Engineering  
University of Saskatchewan  
Saskatoon, Canada**

**Chad Dennis Salewich**

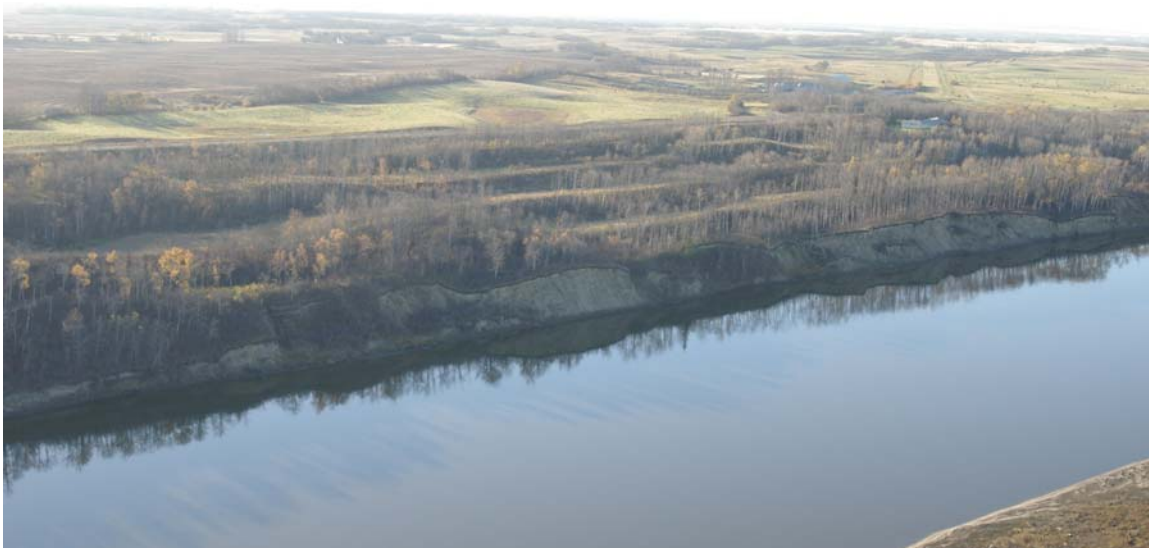
**Figure 3.2: Aerial view of Highway No. 302 Landslide site (Photograph courtesy of Vista Photography).**

Highway No. 302 is part of the Saskatchewan Provincial Highway network and runs through the city of Prince Albert. Approximately 5 km west of Prince Albert (Figure 3.1) an active landslide affected a portion Highway No. 302 resulting in cracking and deterioration of the road surface. The landslide affected approximately 1 km of the highway where it runs nearly parallel to the river approximately 250 m away. The landslide is illustrated in the aerial oblique photograph, Figure 3.2.

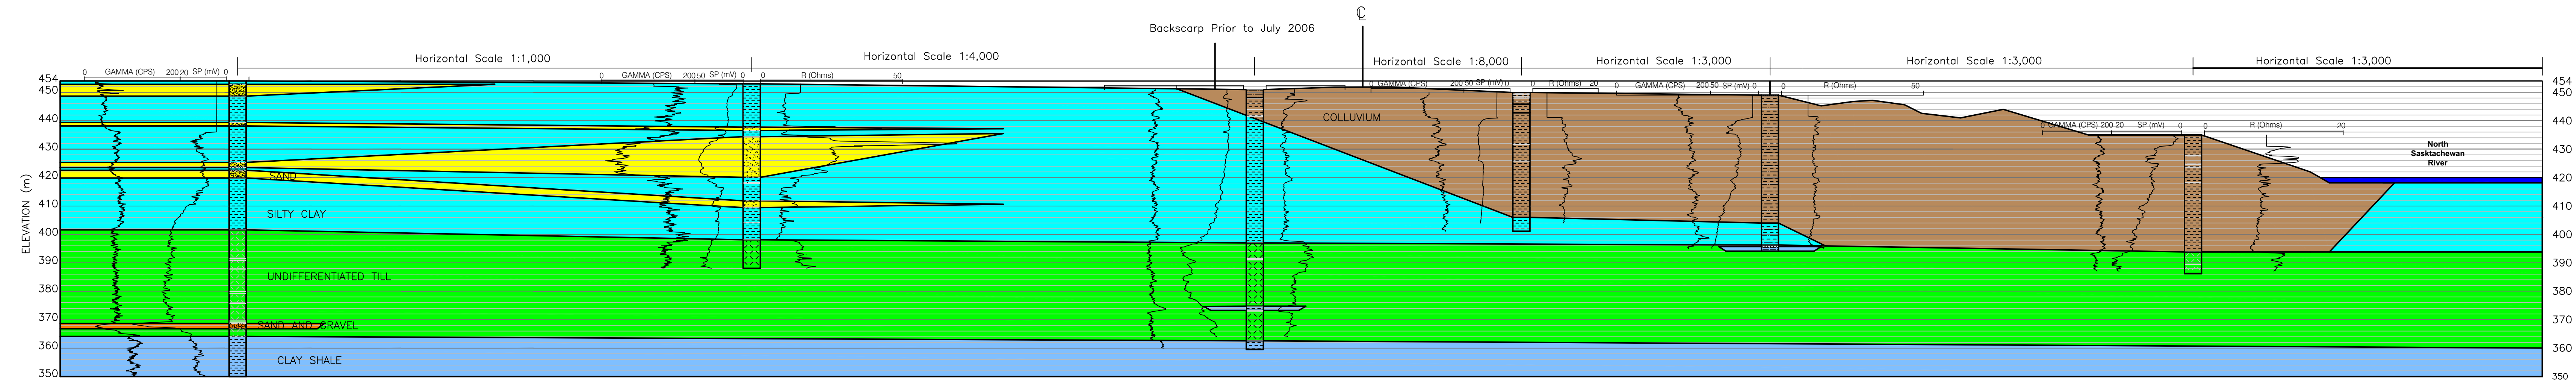
Figure 3.4: Site cross section B-B'

The failure surface is quite planar occurring near the silt/clay and till contact. Failure at this zone is likely due to the difference in strength between highly plastic clay and till material.

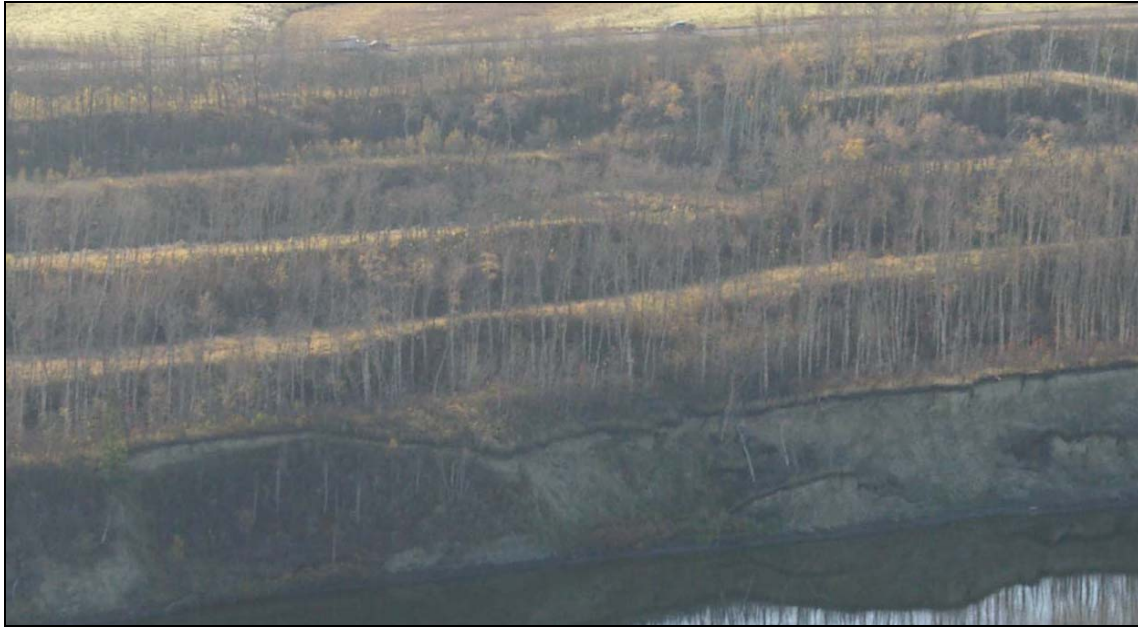
**Figure 3.5: Surface morphology of the Highway No. 302 landslide (from Kelly et al. 2005a).**

The landslide morphology is hummocky and typical of multiple retrogressive landslides found throughout the banks of the North and South Saskatchewan Rivers (Christiansen and Sauer 1984). Figure 3.5 shows the topography formed from multiple retrogressive landslide action as well as the influence of river erosion at the toe of the slide mass. Observation of the slumping blocks at the river's edge indicates that the surficial silts and clays are being eroded by the river, causing shallow rotational failures.

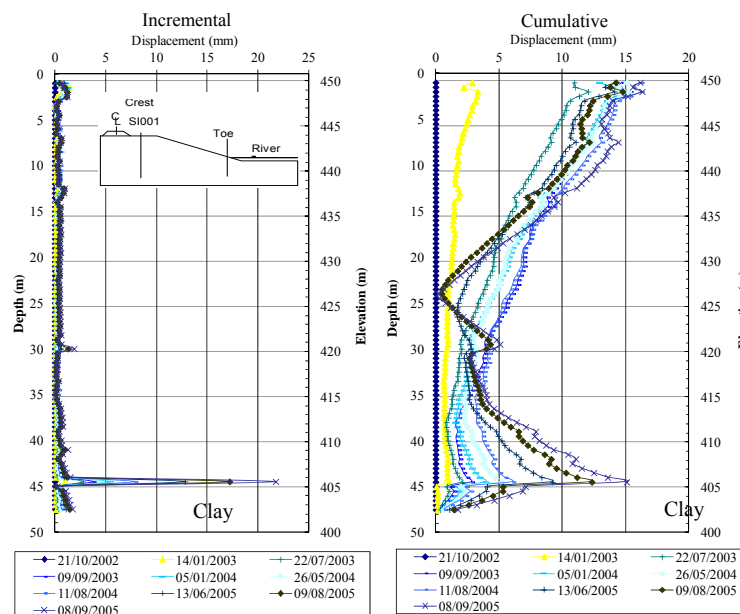
**Figure 4.1: Incremental and cumulative resultant displacement for SI001.**

The first SI casing (SI001) was installed in the north ditch of Highway No. 302 and was monitored 30 times between October 2002 and September 2005. The monitoring results (Figure 4.1) indicate the existence of a major shear zone at a depth of approximately 44.5 m (Elev. 406.2 m) within the lacustrine clay. Resultant incremental movement at the shear zone showed nearly 22 mm of movement towards the north during this time period, while cumulative movement indicates only 16 mm. The cumulative values from SI001 are considered suspect because the base of the casing shows movement.

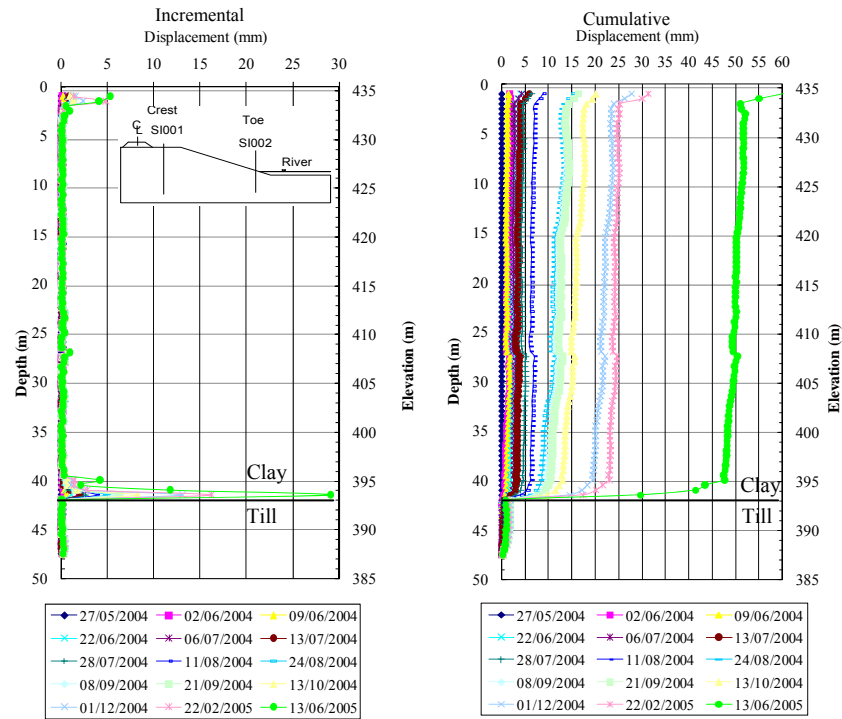
**Figure 4.2: Incremental and cumulative resultant displacement for SI002.**

The continuing movement in SI001 led to the installation of SI002 (located at the toe of the slope) in May 2004. SI002 casing was installed to a depth of 47.5 m (Elev. 388.0 m). The incremental and cumulative resultant displacement readings for SI002 are presented in Figure 4.2. There was approximately 47 mm of movement perpendicular to the river at a depth of 41.5 m (Elev. 393.95 m) from May 2004 to June 2005. The movement at SI002 occurred in the clay just above the contact between the clay and till.

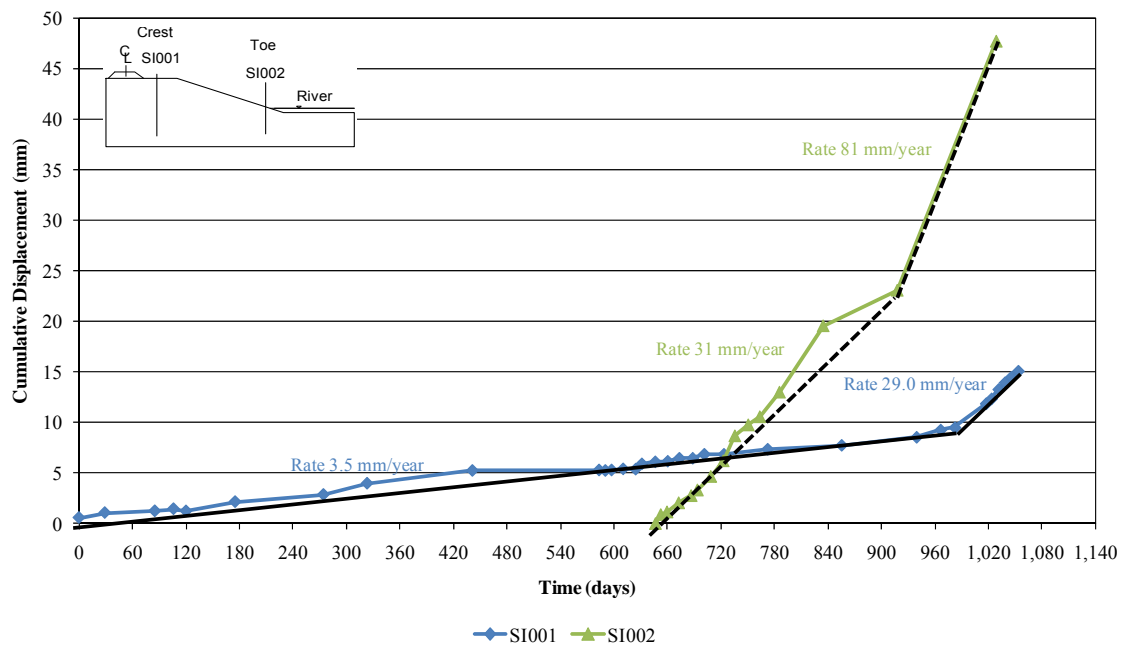
**Figure 4.3: Cumulative displacement versus time at SI001 and SI002.**

crest was approximately 3.5 mm per year, whereas the rate of movement at the toe was 31 mm per year, as shown in Figure 4.3. During February 2005, the rate of movement at the toe of the slope increased to 81 mm per year. By June 2005, the rate of movement at the crest of the slope increased to 29 mm per year. The delay between the increased rate of movement at the toe (February 2005) and the increased rate of movement at the crest (June 2005) was approximately 60 days. The observation that the toe of the slope is moving more quickly than the crest of the slope is in agreement with the conclusion reached by Kelly et al. (2005a). It should be noted though that the readings from SI001 are suspect so the rate of movement at the toe was affected. Moving the installation of crest monitoring with SI003 and re-calibrating the traversing slope inclinometer probe provided more reliable readings for the subsequent installations.

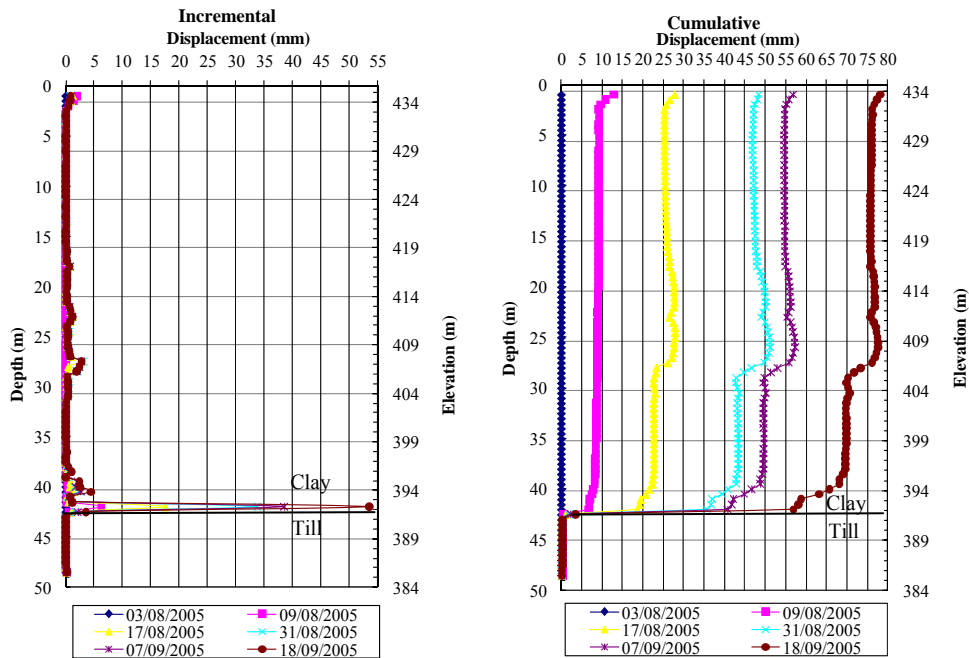
**Figure 4.5: Incremental and cumulative resultant displacement for SI102.**

SI102 was installed to a depth of 48.0 m (Elev. 387.5 m). After installation, a well-defined shear zone was observed at a depth of 42.0 m (Elev. 393.2 m), in Figure 4.5. A minor slip surface appeared to be developing at a depth of 40.0 m (Elev. 395.2). Movement rates were 541 mm per year at the toe and 483 mm per year at the crest of the slope when considering total cumulative movement at SI003 and SI102 between March 2005 and September 2005 (Figure 4.7).

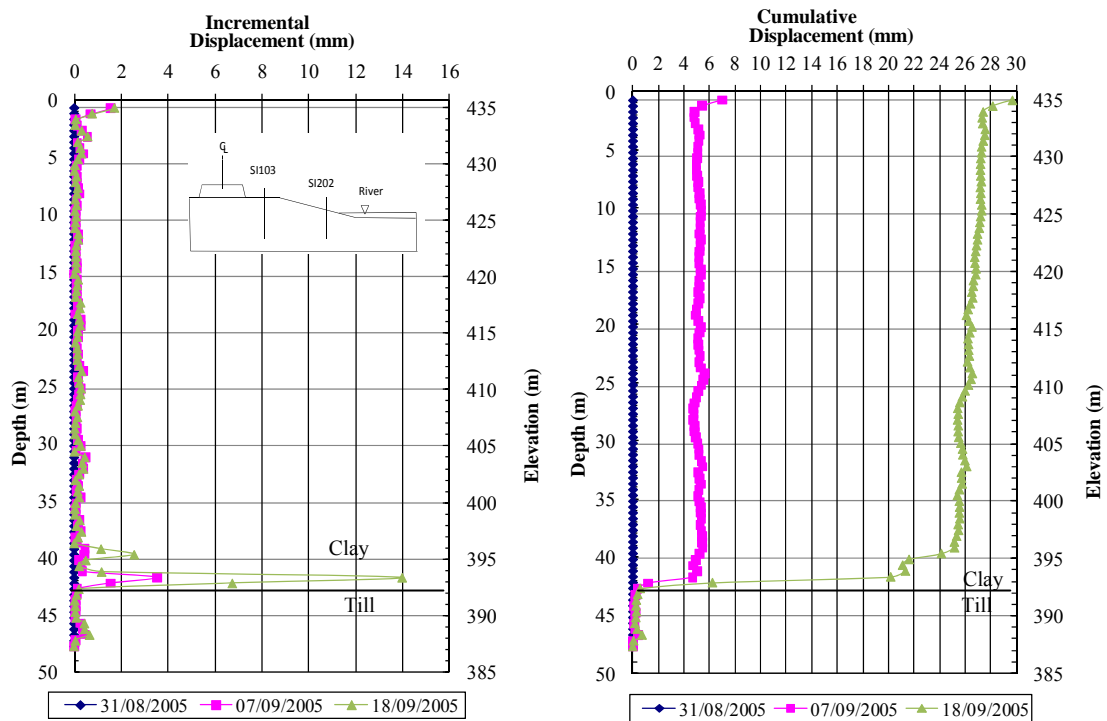
**Figure 4.8: Incremental and cumulative resultant displacement for SI202.**

SI202 was installed to a depth of 48.0 m (Elev. 387.2 m). The initial survey of the casing for SI202 was conducted on August 31, 2005 and the final survey on September 18, 2005. A distinct shear zone located at a depth of 41.8 m (Elev. 394.0 m) was noted after the completion of these surveys. Approximately 20 mm of movement was measured at 41.8 m depth and a total 25 mm of movement had occurred between a depth of 39.75 m and 41.8 m (Elev. 394.0 m and 396.5 m) (Figure 4.8). Between August 31, 2005 and September 7, 2005, 5 mm of movement occurred at a depth of 41.8 m, and over the next 12 days between September 7, 2005 and September 18, 2005, 20 mm of movement occurred.

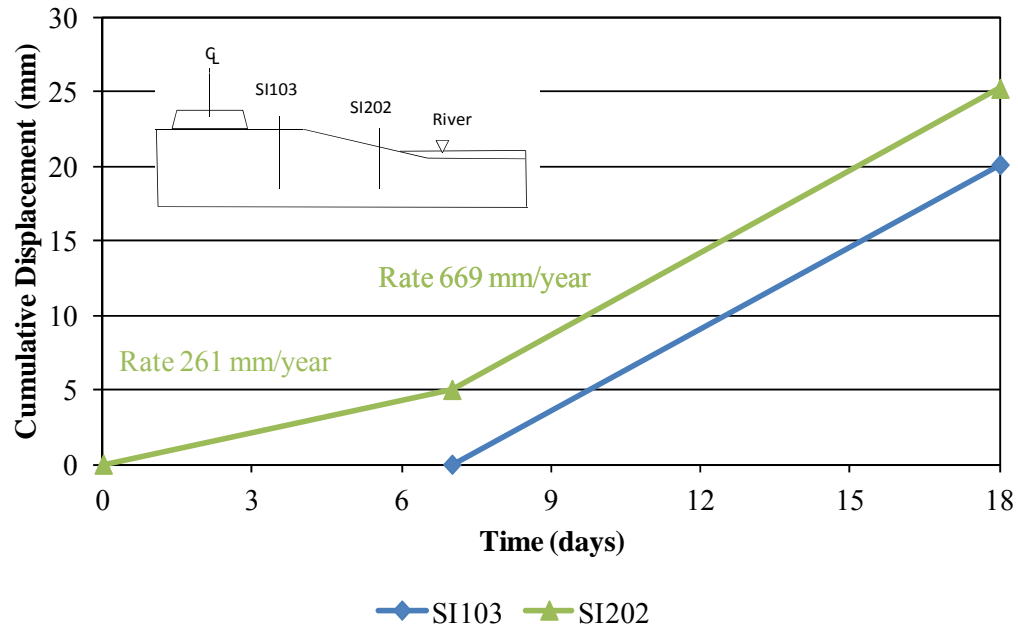
Comparisons of the rates of movement at the crest and toe (Figure 4.9) showed that the rates of movement were nearly the same. This indicated that all the constituent blocks of the slope were now moving at nearly the same rate and that global failure of the slope had been triggered.

Figure 4.9: Cumulative displacement versus time at SI103 and SI202.

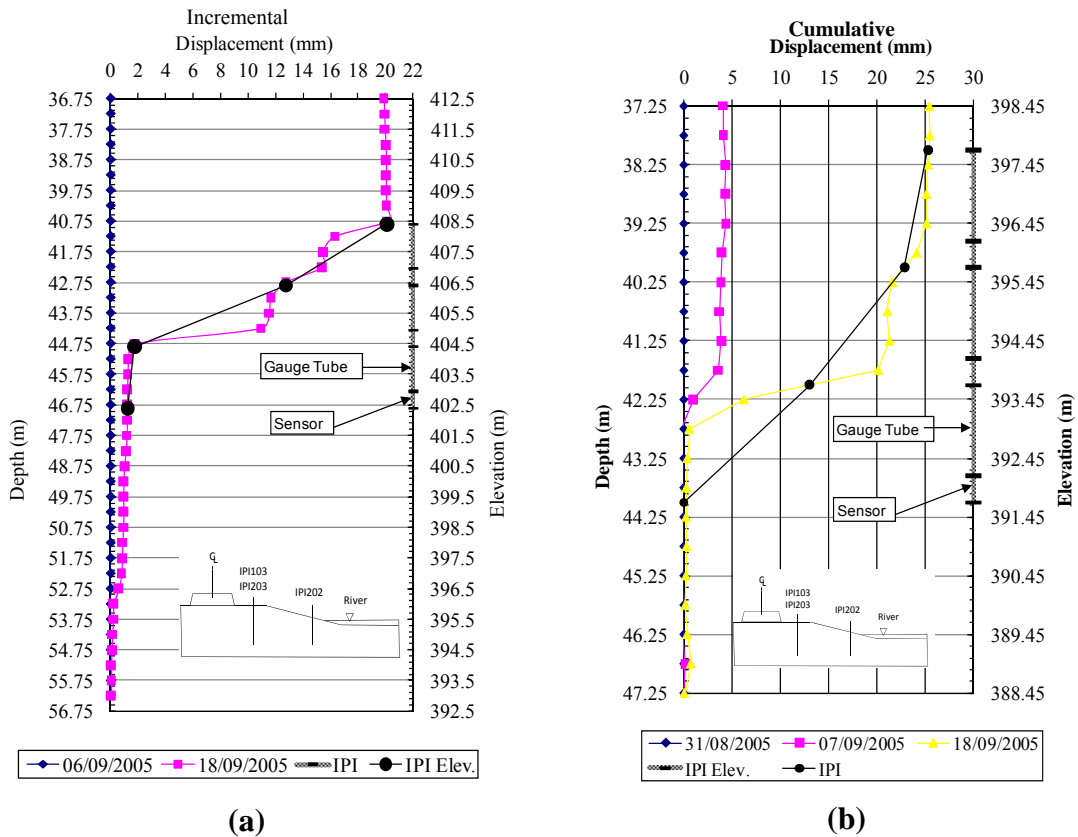
Figure 4.10(a) displays the initial position of IPI103 near the highway based on the last traversing slope inclinometer probe readings dated September 18, 2005. Using the resultant cumulative deflection plot, it was observed that the lowermost sensor was placed below the zone of movement, and the two uppermost sensors were placed within the zones of movement.

The initial position of IPI202 is shown in Figure 4.10(b). The bottom sensor gauge tube extended 0.75 m above the shear zone, while the IPIs sensor (length 0.55 m) and 0.70 m of gauge tubing remained below the shear zone. The top two sensors were located within the moving portion of the casing. It appears that the two uppermost sensors were located within an S-shape deformed portion of the casing.

Figure 4.10: (a) Initial placement of IPI103 (SI103) and (b) Initial placement of IPI202 (SI202).

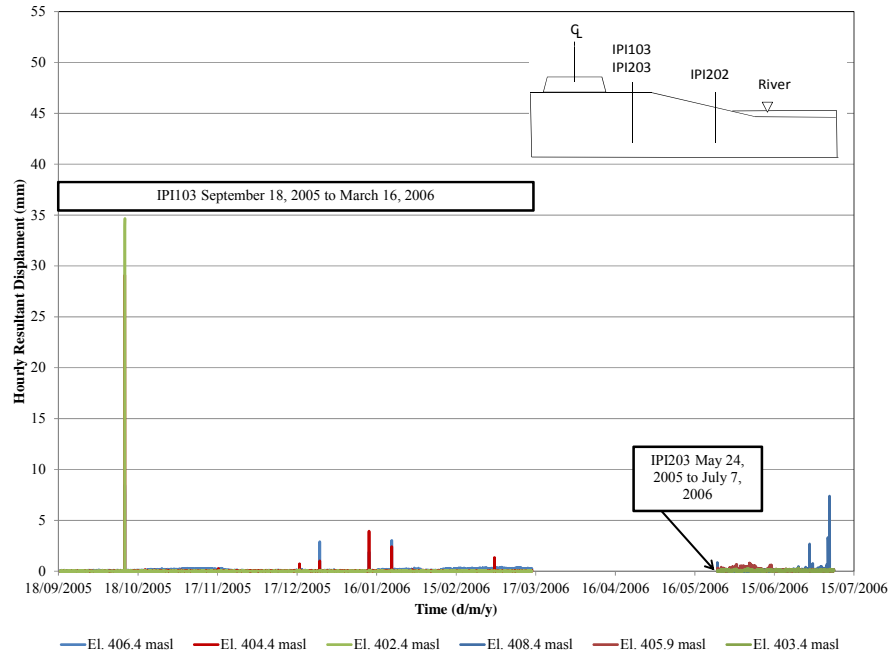
**Figure 4.11: Hourly incremental resultant displacement of each sensor at IPI103 and IPI 203.**

Figure 4.11 shows the results for IPI103 and IPI203. The general trend indicates that movement is typically an accumulation of small displacements. There are displacements on the graph where spikes of movement occur over a one hour period. For instance between 00h00 and 01h00 on October 13, 2005 all three IPIs comprising IPI103 showed displacement. The largest

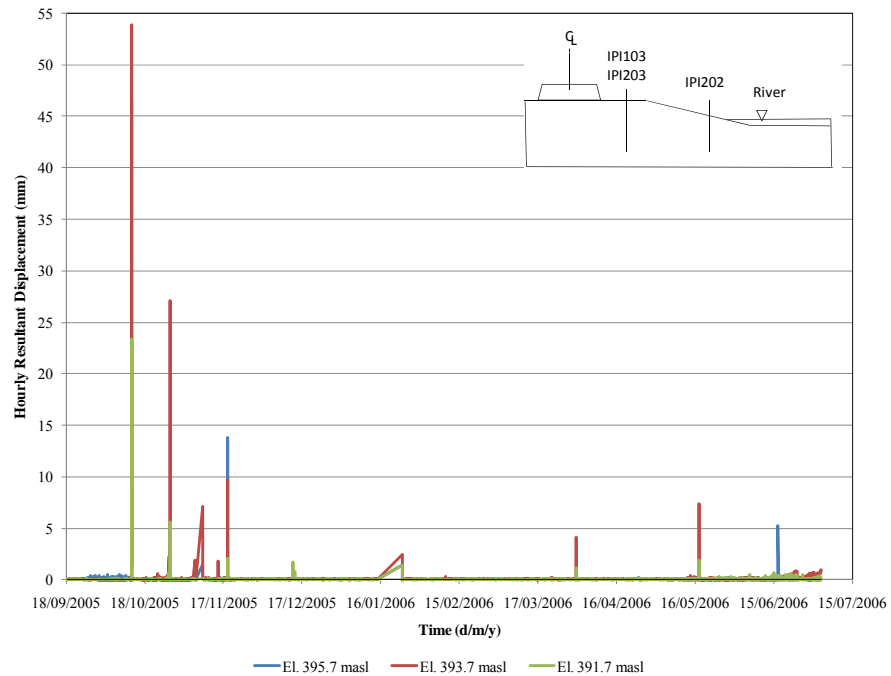
**Figure 4.12: Hourly incremental resultant displacement of each sensor at IPI202.**

The movement recorded by IPI202 (Figure 4.12) also appeared to be accumulated small strains except for three significant spikes in displacement in October and November 2005. The initial spike disturbed the middle and the bottom IPIs of IPI202. The middle sensor showed displacement of nearly 55 mm while the bottom sensor showed displacement of 23 mm. This displacement occurred 20 minutes after the displacement spikes noted near the highway in IPI103 on October 13, 2005. The next major movement occurred on October 27, 2005 and November 18, 2005. The October 27 movement affected the middle and bottom IPIs while the November 18, 2005, affected the top IPIs more than the middle and the bottom IPIs.

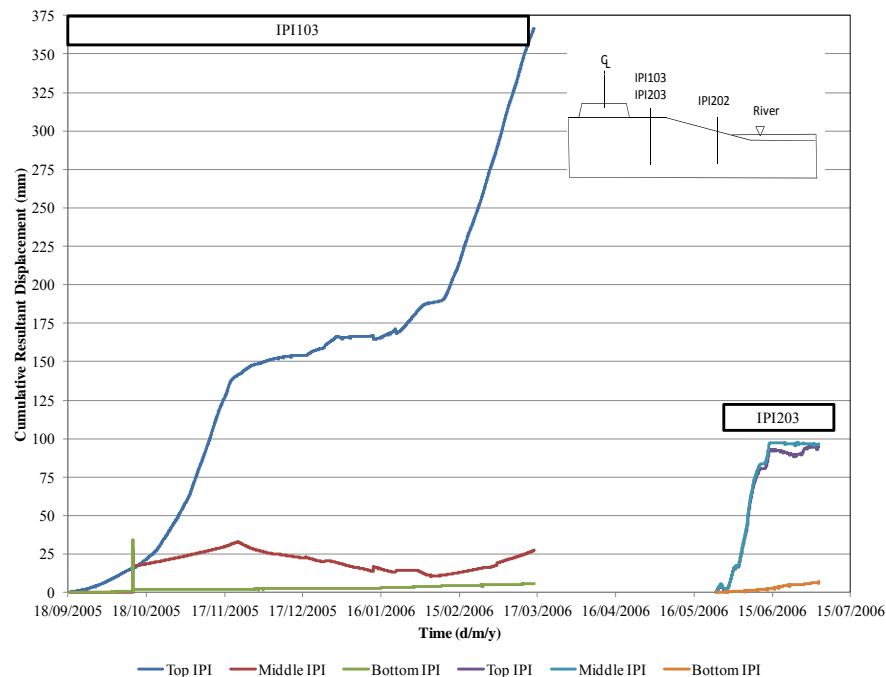
**Figure 4.13: Cumulative resultant displacement of each sensor at IPI103 and IPI203.**

IPI103 (Figure 4.13) indicates movement during the fall and relatively slow rates of movement during the winter. Increased rates of movement begin again in February 2006 until destruction of IPI103 on March 15, 2006. IPI203 showed movement right after installation and this continued between May and July 2006 until it was destroyed. The majority of the movement in IPI203 was attributed to the middle IPIs with relatively little movement experienced in the upper and lower sensors.

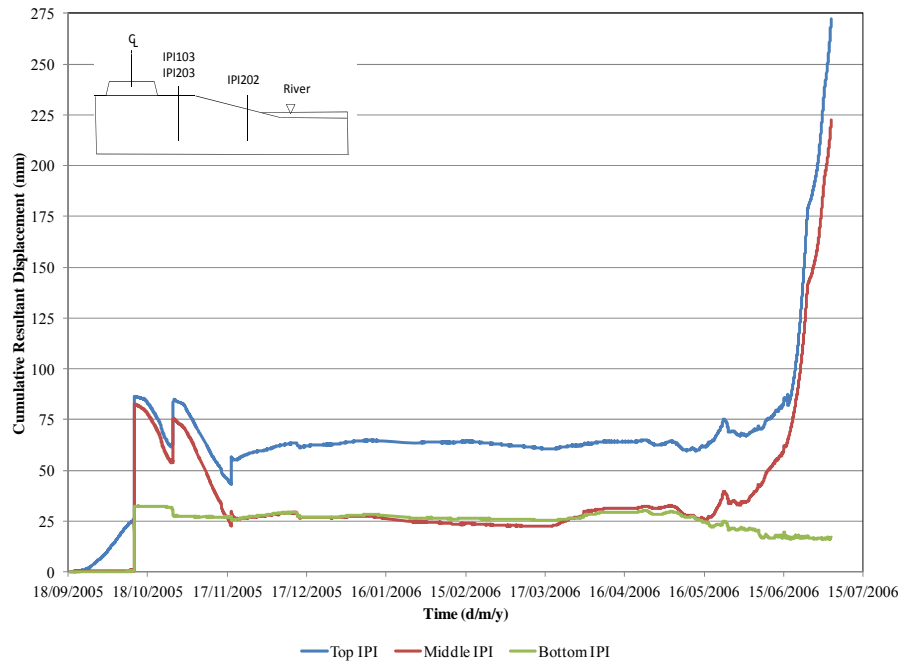
**Figure 4.14: Cumulative resultant displacement of IPI202.**

IPI202 (Figure 4.14) showed 25 mm of movement between September 18, 2005 and October 13, 2005. After the initial disturbance on October 13, 2005 the movement reversed and became positive. This movement was associated with the high incremental hourly movements. This phenomenon will be discussed further in Chapter 5. Movement in the spring highlights the increased rate of movement until IPI202 was no longer functional by July 2, 2006.

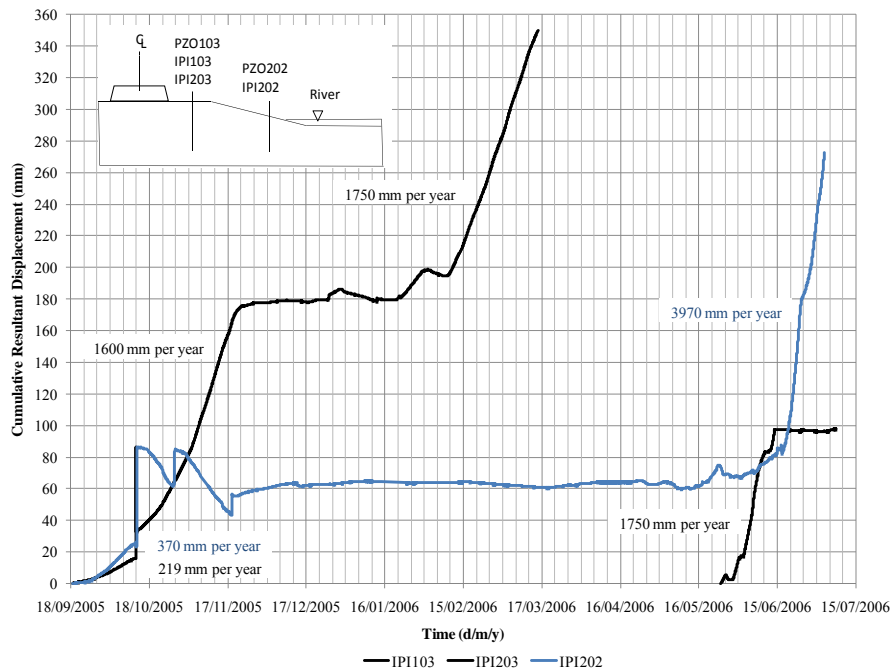
**Figure 4.15: Comparison of cumulative resultant movement for IPI103, IPI203 and IPI202.**

Figure 4.15 provides the average rates of movement based on the cumulative resultant value for each IPIs installation. Prior to the disturbance on October 13, 2005 movement rates were 370 mm per year at the toe compared to 219 mm per year at the crest. No slope movement was observed at the toe during the increased movement of the crest during February 2006. According to IPI202 movement initiates during the second half of May 2006. By mid-June the movement rate increased to 3970 mm per year. A rate of 1750 mm per year was observed during May and June 2006 at IPI203. Comparing the rate of movement between the toe and the crest of the slope, the movement rate at the toe is 2.2 times that observed at the crest.

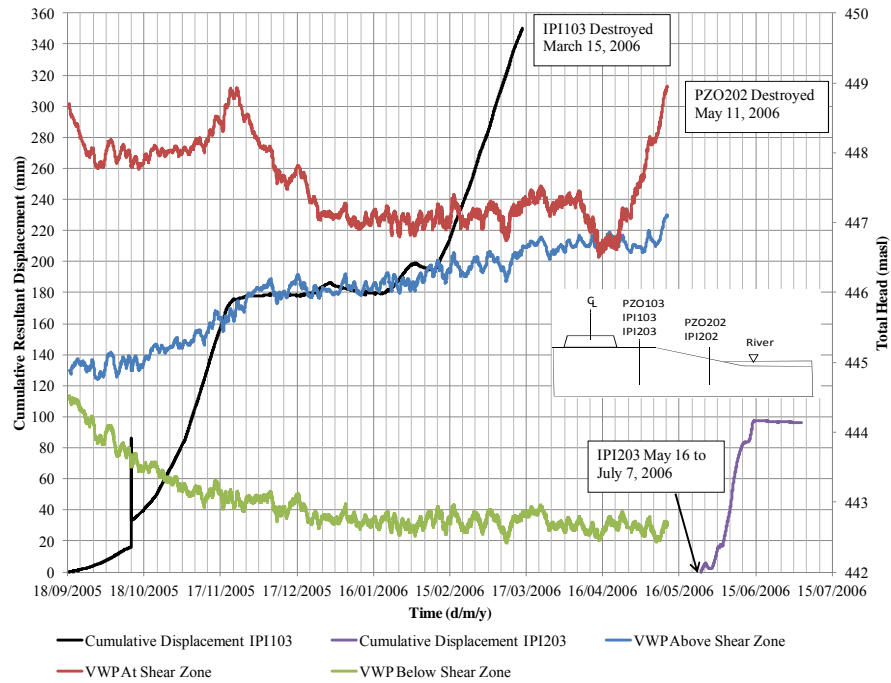
**Figure 4.16: Comparison of movement at the highway (IPI103 and IPI203) with pore-water pressure measurements (PZO103).**

Periods of movement appear to have caused the increases in pore-water pressure shown in Figure 4.16. An increase movement rate from 219 mm per year to 1600 mm per year between October 13, 2005 and November 23, 2005 was associated with a 1.2 m increase in total head at the piezometer nearest to the shear zone.

During the winter period (November to February) there was virtually no movement of the slope. A dissipation of pore-water pressures at the shear zone was observed. The slope began to move again on February 6, 2006 and the rate of movement increased to 1500 mm per year. No significant change in pore-water pressure was noted with the increase in movement during the winter. IPI103 was destroyed by March 15, 2006. An additional increase in pore-water pressure of 2.5 m occurred near the shear zone between April 21, 2006 and May 11, 2006 after which time the VWP's stopped functioning. Since IPI103 was already destroyed and IPI203 had not been installed, displacement associated with this increase in pore-water pressure was not monitored.

Over the entire monitoring period, between September 18, 2005 and May 11, 2006, the total head above the shear zone increased steadily by 2.2 m. The VWP's below the shear zone indicated a total head decrease of approximately 2.0 m. In general the total head in the shear zone was the highest followed by the total head above the shear zone and the lowest values below the shear zone.

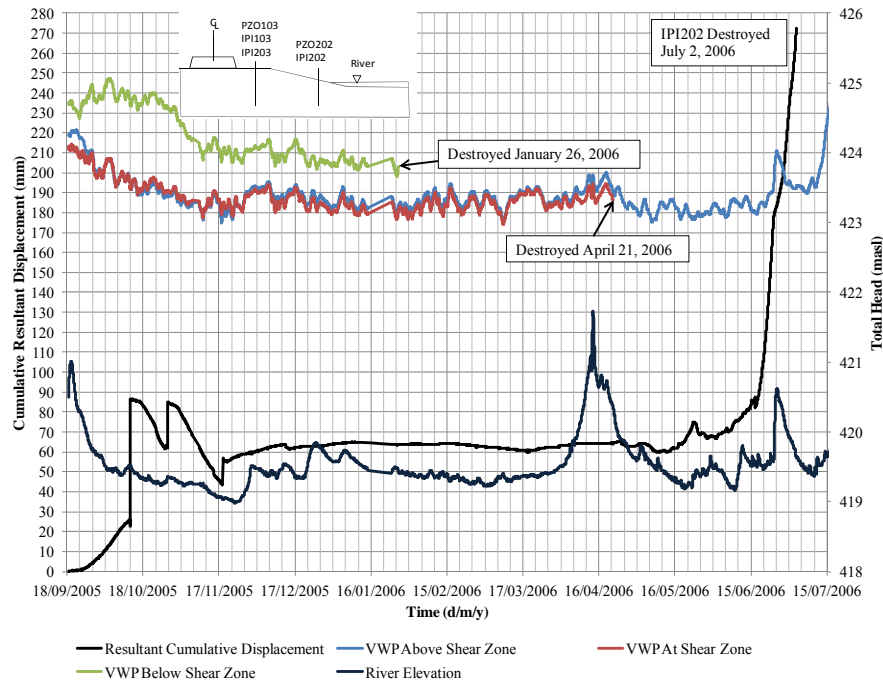
**Figure 4.17: Comparison of movement near the riverbank (IPI202) to pore-water pressure (PZO202) and river level.**

Figure 4.17 includes the data from the VWP installed above, below and at the shear zone, river elevation and IPI's displacement. The elevation of the river bed was assumed to be 418.16 m based on air photo interpretation (Kelly et al. 2005a).

The pore-water pressure at the toe of the slope remained fairly stable during the monitoring period with maximum pressure heads fluctuating by less than 1 m. Levels of pore-water pressure remained high initially and dropped throughout the winter. The piezometers below and at the shear zone failed prior to the spring of 2006. The VWP above the shear zone continued to provide data throughout the monitoring period and displayed a delayed pore-water pressure increase after spring movement was initiated. Two periods of movement were observed where the rate of movement increased after a rise and fall in the river level in September 2005 and April 2006.

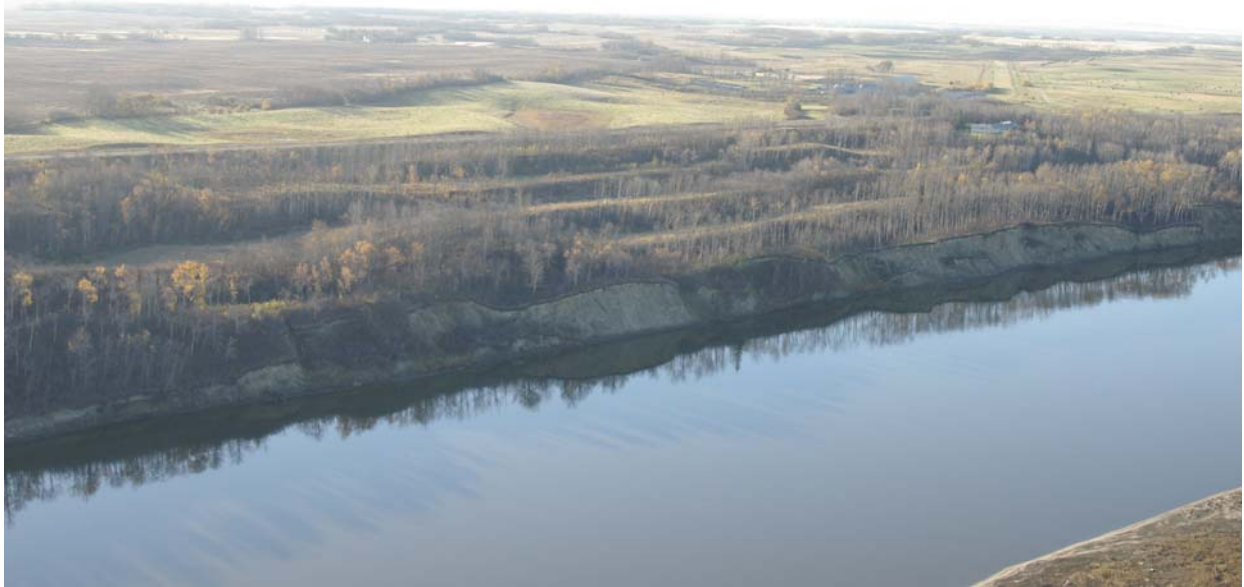
**Figure 5.2: Oblique aerial view of the topography of the Highway No. 302 landslide (Photograph courtesy of Vista Photography).**

Stauffer et al. (1990) described the extension of a land mass and illustrated the resulting topography of a retrogressive landslide (Figure 5.1). The resulting topography depended on the amount of movement from crest to toe. Figure 5.1b highlights a scenario where all landslide blocks extend equally and the surface is composed of horst and graben features at approximately the same level. Figure 5.1c shows a scenario where 30% extension occurs at the toe reducing to 10% at the crest of the slope. An oblique aerial view of the landslide (Figure 5.2), resembles Figure 5.1c confirming the retrogressive nature of the Highway No. 302 landslide.

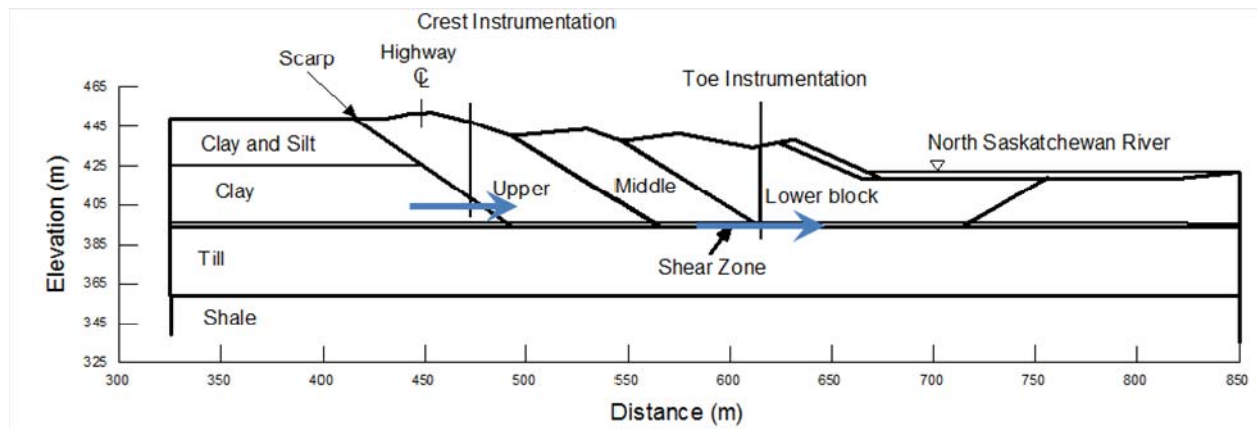
1. Translational movement at the crest was greater than that at the toe of the slope for a period of time (Figure 5.3);
2. The movement recorded by IPIs sensors at the crest was magnified due to a combination of horizontal shear and vertical compression of the casing (Figure 5.4); or
3. Accurate movement of the slope could not be recorded due to poor sensor position control, likely caused by the casing pushing on the sensors because of excessive deformation of the casing.

**Figure 5.3: Scenario #1, horizontal shear at the slope crest greater than horizontal shear at the slope toe.**

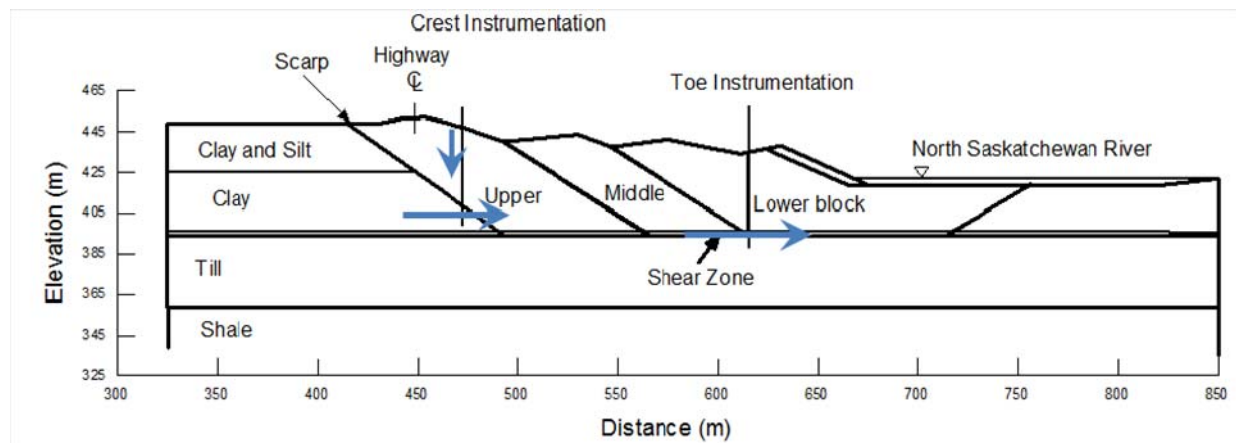
Scenario #2 considers vertical settlement coupled with shear displacement. Vertical settlement was observed at the site during the monitoring with the IPIs and was most significant during the spring and summer of 2006 (see photographs in Appendix A). Although no additional survey was conducted of the settlement at the instrument large settlements were noted at the crest of the slope. The manufacturers suggest that when settlements greater than 1% to 2% of the installation depth are expected, a telescoping coupling may be required to avoid buckling of the casing (DGSI 2009). This corresponds to 0.5 m to 1.0 m of settlement at the crest of the slope for the Highway No. 302 site. A combination of buckling and horizontal shear could compound casing deformation. Vertical settlement would show up as greater horizontal displacement rates and could potentially result in premature destruction of the casing.

**Figure 5.4: Scenario #2, vertical settlement and horizontal shear at the slope crest compounding casing deformation.**

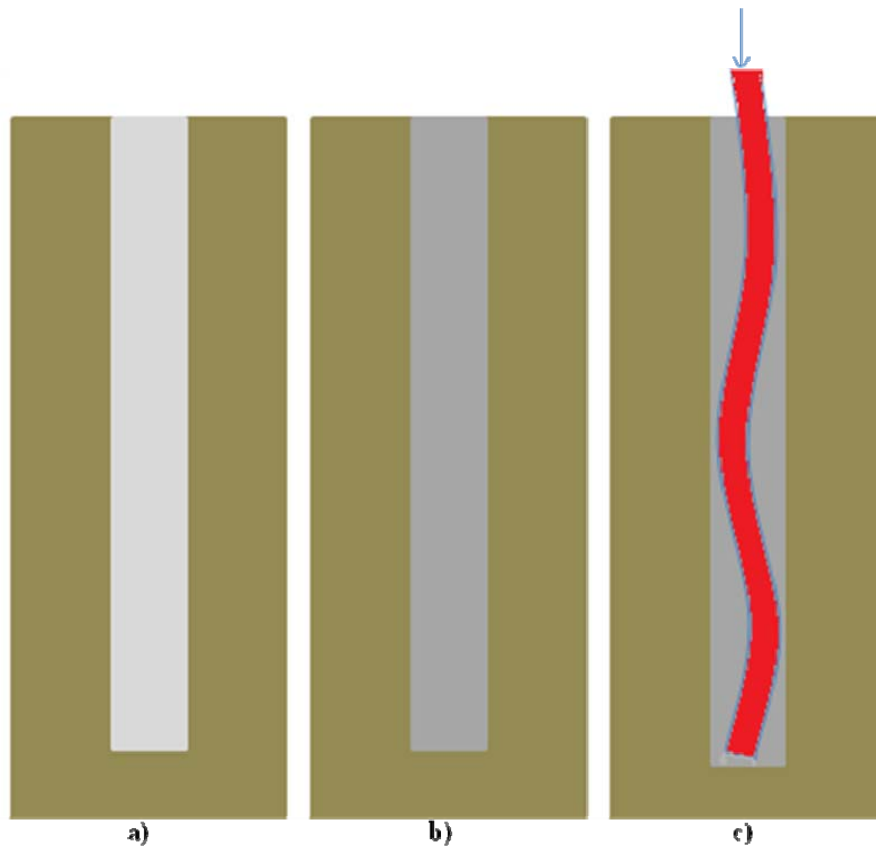
The slope inclinometer casing at Highway No. 302 was installed by pushing it through the grout and holding the casing from the top with the drill rig until the grout had set. DGSI (2009) describes this method of installation as the easiest but the worst way to overcome casing buoyancy. The problem with this method is that the casing goes into compression. This compressive force induces a wavy profile in the casing because of the flexibility of the casing (Figure 5.6). A wavy casing profile can increase the potential for the casing to contact the probe and reduce the lifespan of the casing. For example, if the IPIs probe were placed through an S-shape curve in the casing, the deformation of the casing may cause the probe to be near the casing wall and reduce the installation lifespan. Additionally, installation of the IPIs probe through the curved portions could affect the ability of the IPIs wheels to stay on track in the casing.

**Figure 5.6: Sketch of the installation of slope inclinometer casing showing, a) drilled borehole with drilling fluid, b) replaced drilling fluid with cement-bentonite grout and c) install slope inclinometer casing by pushing and weighting from top until grout sets.**

This problem increases with the increasing depth of installation. To avoid this situation a bottom anchor, bottom weight or pinning the casing from the bottom is recommended.

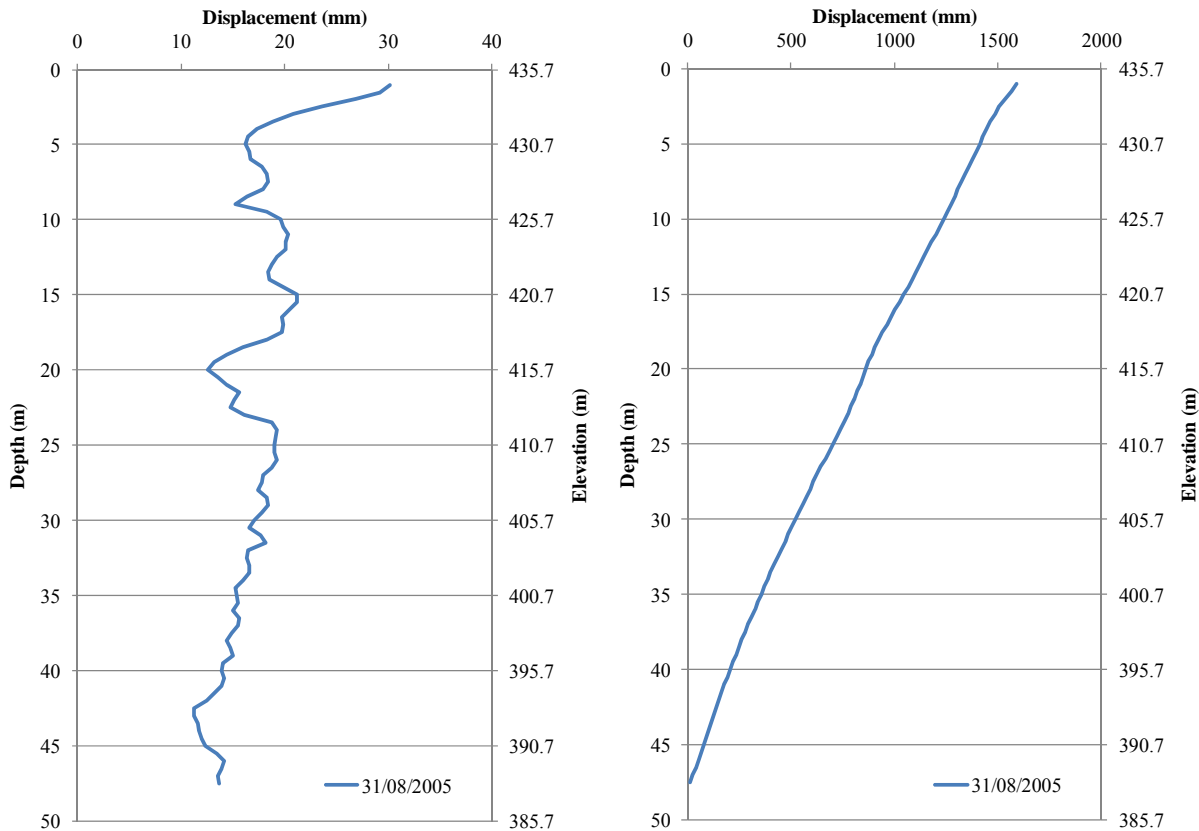
Finally, due to the depth of the borehole there was potential for the borehole to deviate from vertical. Figure 5.7 presents the profile of the SI202 at the toe of the slope which housed the IPIs that showed movement reversal. It is evident in this figure that there were problems with both curvature (wavy profile) and verticality since the casing was also found to deviate 1.9° to the south west. Both of these attributes can reduce the casing lifespan since by reducing the annular space and forcing the probe out from its grooves prematurely. A tilted installation can also reduce the lifespan since the probe is calibrated from vertical to  $\pm 10^\circ$  and the initial tilt of the casing can reduce the amount of tilt available before the calibrated range is breached.

**Figure 5.7: Initial casing survey highlighting resultant incremental displacement (casing straightness, left plot) and resultant cumulative displacement (casing profile, right plot).**

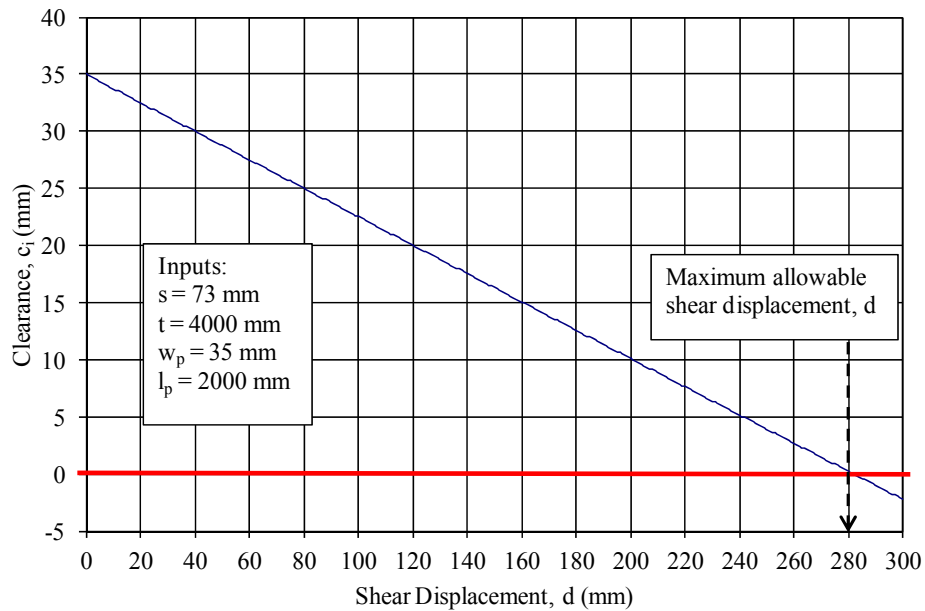
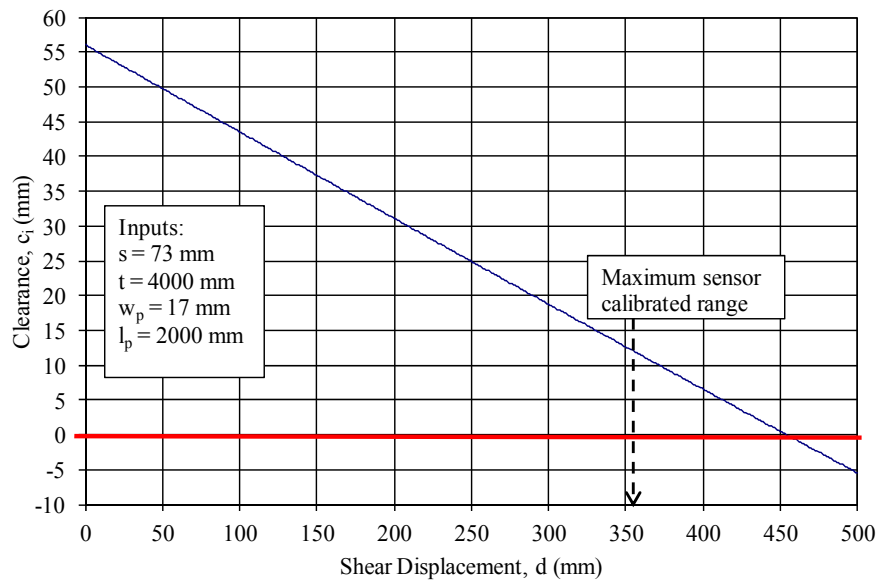
Figure 5.14 and Figure 5.15 highlight the results from the analysis at IPI103. With a shear induced deformation profile thickness, t, of 4.0 m and a probe length, l<sub>p</sub>, of 2.0 m the casing displaces 280 mm prior to casing contact with the probe. If the gauge length diameter of 17 mm

is used the IPIs sensor would exceed its calibrated range of  $10^\circ$  before the casing curvature affects the sensor. This analysis indicates that the disturbance to the sensor on October 13, 2005 was likely due to settlement of the top assembly; since it is unlikely that casing affected the sensors.

**Figure 5.14: Clearance,  $c_i$ , versus shear displacement,  $d$  for IPI103 using the probe diameter of the sensor,  $w_p$ .**

**Figure 5.15: Clearance,  $c_i$ , versus shear displacement,  $d$  for IPI103 using the smaller gauge tubing diameter,  $w_p$ .**

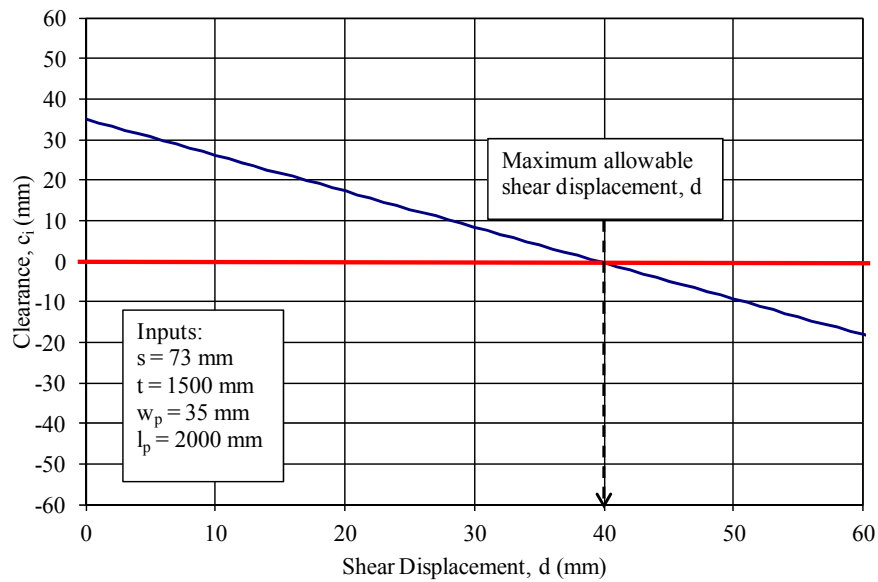
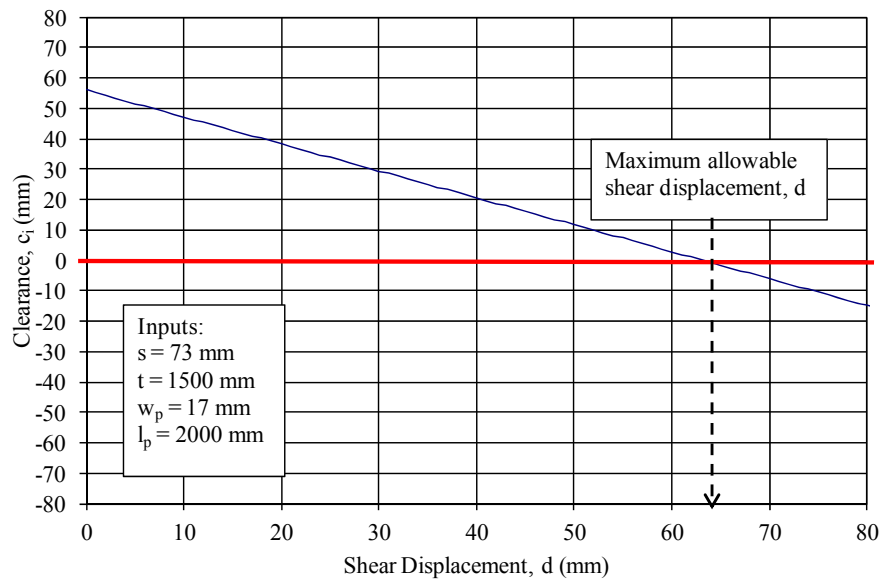
For IPI202 the shear induced deformation profile thickness,  $t$ , was 1.5 m and the gauge length,  $l_p$  was 2.0 m. Figure 5.16 and Figure 5.17 highlight the resulting maximum allowable shear deformation. In this case since the gauge length is longer than the shear zone and much less allowable deformation can occur before contact of the casing with the probe. For the case where the probe diameter is 38 mm, 40 mm is the maximum allowable shear displacement. The maximum allowable shear displacement increases to 63 mm when the 17 mm diameter gauge tubing is used. Since IPI202 deflected approximately 21 mm prior to installation of the IPIs and an additional 27 mm with the IPIs itself it is possible that the disturbance on Oct 13, 2005 was caused by contact of the probe with the casing. The analysis indicates that the IPIs could contact the casing between 40 mm and 63 mm of shear displacement.

**Figure 5.16: Clearance,  $c_i$ , versus shear displacement,  $d$  for IPI202 using the probe diameter of the sensor,  $w_p$ .**

**Figure 5.17: Clearance,  $c_i$ , versus shear displacement,  $d$  for IPI202 using the smaller gauge tubing diameter,  $w_p$ .**
